Sankofa Wetland Park Monitoring Report

April – June 2024

Septic Water Intrusion at the Sankofa Wetland Park

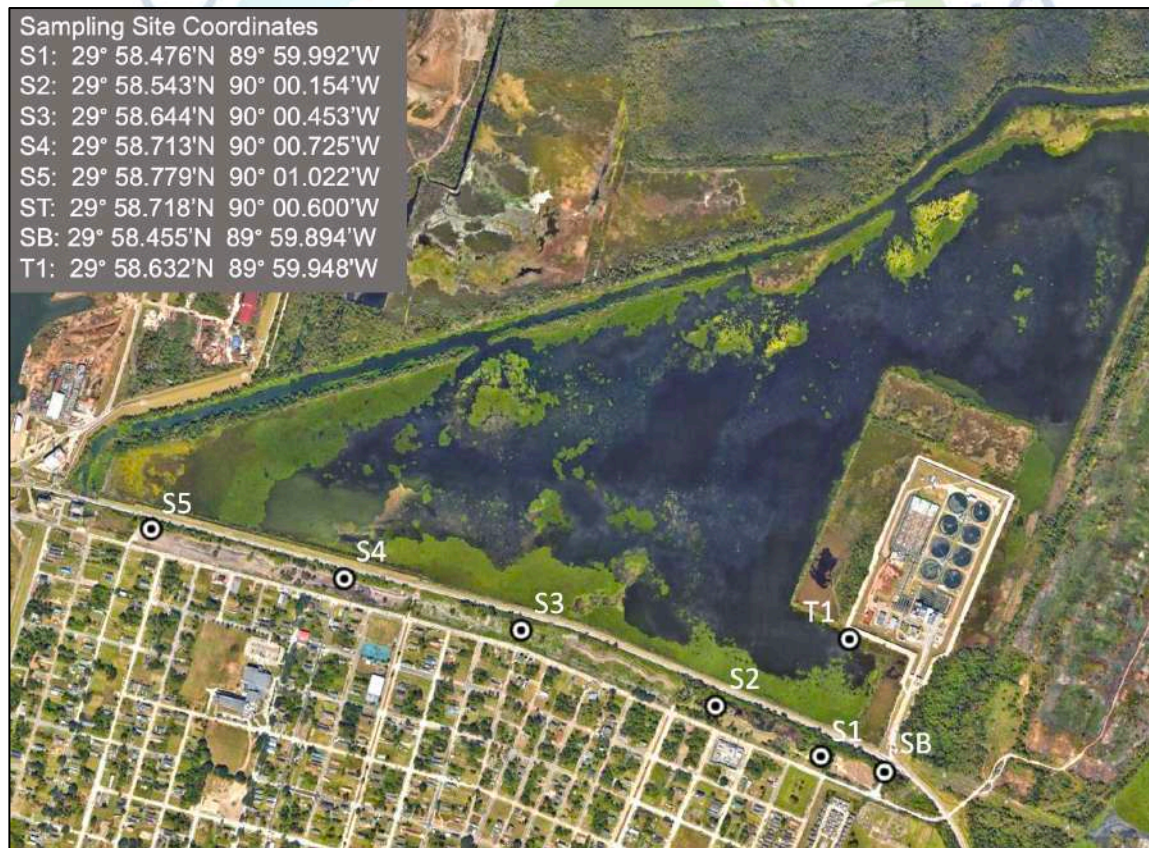
Location of sampling sites at the Sankofa Wetland Park (S1-S5), the St. Bernard drainage ditch (SB), and the Bayou Bienvenue Wetland Triangle (site T1).

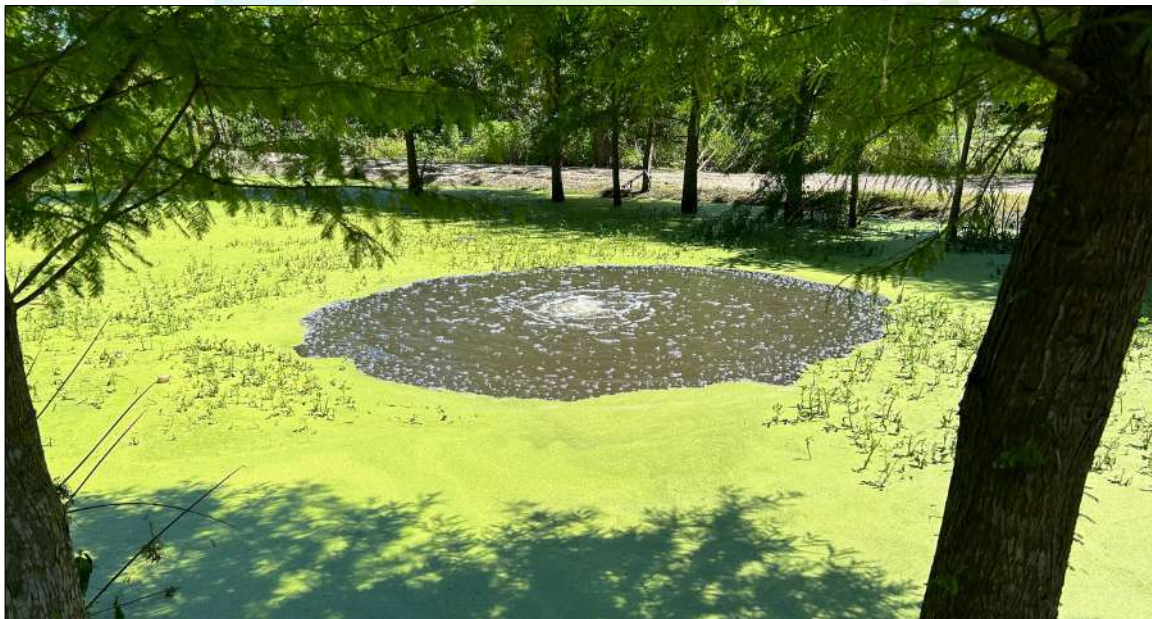
The aerator working at site S1 – it was stolen shortly after this pic was taken on April 30, 2024.

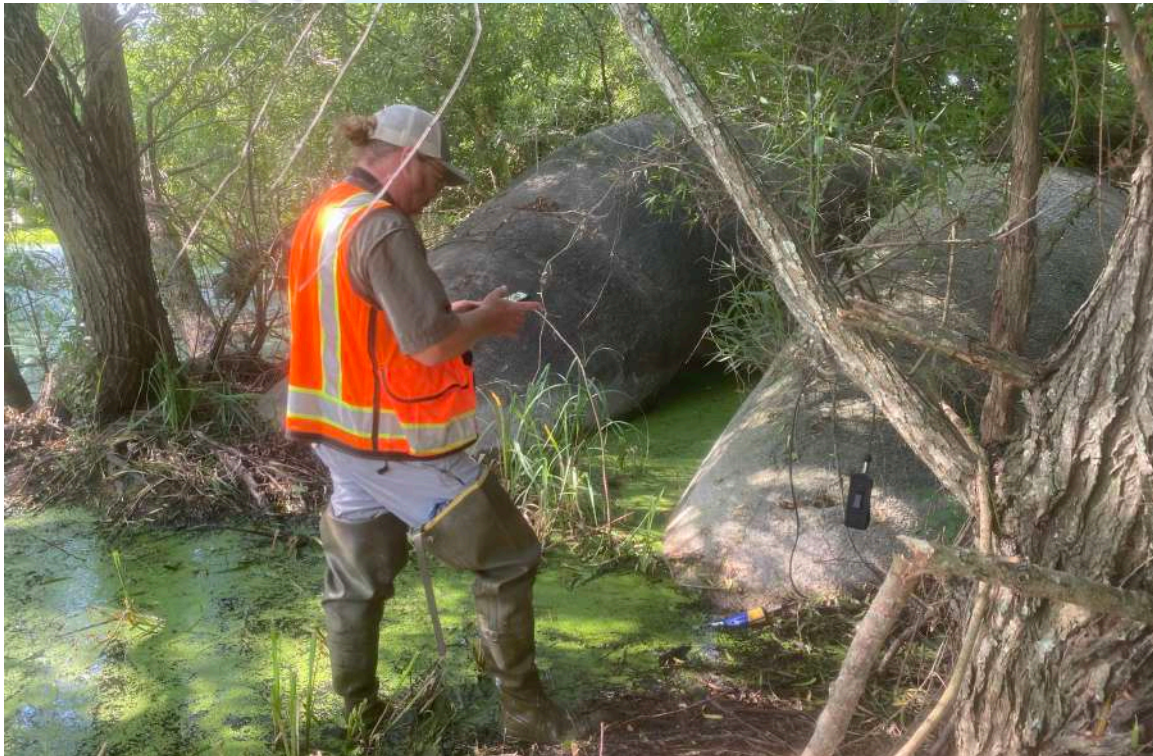
Jason Day taking water quality measurements at the leaking septic pipe on May 23, 2024.

Dissolved oxygen was 1.6 mg/L at the bridge (SB), 2.1 mg/L at the leaking septic pipe (SP), 0.5 mg/L at sites and S2, 8.3 mg/L at site S3, 9.9 mg/L at site S4, 2.3 mg/L at site S5, and 1.4 mg/L at the wetland triangle site (T2). **Note the very low DO concentrations at sites S1 & S2 – this is most likely the result of the septic input. We highly recommend instillation of an air bubbler at this location.** Conductivity was ~1033 mS at the SB site, ~1392 mS at the SP site, and ranged from ~730 mS to ~495 mS at the wetland

park sites, and ~2940 mS at site T2. **Note that conductivity is highest at the pipe (SP) and generally decreases going west through the park, suggesting that the St. Bernard canal is the source of conductivity.** Salinity was 0.53 ppt at the bridge (SB), 0.71 ppt at the pipe (SP), and ranged from 0.24 to 0.36 at the wetland park sites (S1-S5), and 1.50 mg/L at the wetland triangle site (T2). **As with conductivity, the St. Bernard canal is the source of salinity to the park.** Water temperature ranged from 24°C to 27°C, and pH ranged from 6.9 to 8.5. Total dissolved solids (TDS) was 0.67 mg/L at the bridge (SB), 0.91 at the leaking pipe (SP), and ranged from 0.32 to 0.47 mg/L in the wetland park, and was 1.83 mg/L at site T2. **Again, the St. Bernard canal is the source of TDS to the park.**

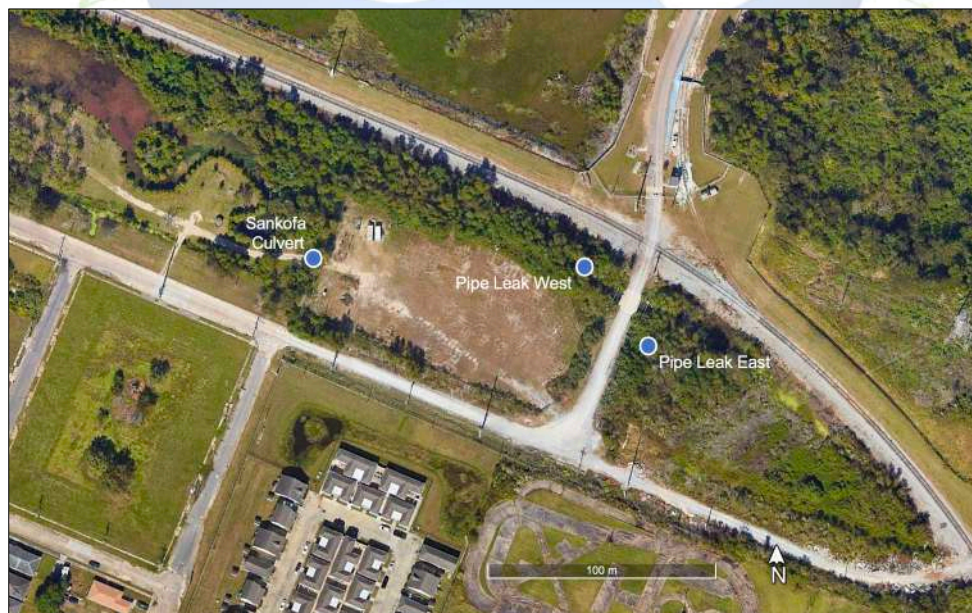
Samples were collected on May 23, 2024 for Fecal Coliform, E. Coli and Enterococcus bacteria analysis, as recommended by Kristi Trail of the Pontchartrain Conservancy. The samples were collected at the two leaking pipes described above located east and west of the road to the Veolia wastewater treatment plant, as well as at the Sankofa Wetland Park culvert.

Locations where samples were taken on May 23, 2024.

The additional samples collected on May 23, 2024, for Fecal Coliform, E. Coli, and Enterococcus bacteria analysis provide critical insights into the microbial contamination in the vicinity of the Veolia wastewater treatment plant and Sankofa Wetland Park with significant variations in bacterial concentrations across the three sampling locations. Fecal coliform bacteria were found to be 265 CFU/100 mL at the eastern pipe leak, 110 CFU/100 mL at the western pipe leak, and a notably high 480 CFU/100 mL at the Sankofa culvert. Similarly, E. coli concentrations were 435.2 MPN/100 mL at the eastern pipe leak, 313.0 MPN/100 mL at the western pipe leak, and 694.7 MPN/100 mL at the Sankofa culvert. Enterococcus bacteria levels were 307.6 MPN/100 mL, 64.2 MPN/100 mL, and 119.1 MPN/100 mL at the eastern pipe leak, western pipe leak, and Sankofa culvert, respectively. See the report appended to this document that details the septic leak issue with discussion of the data.

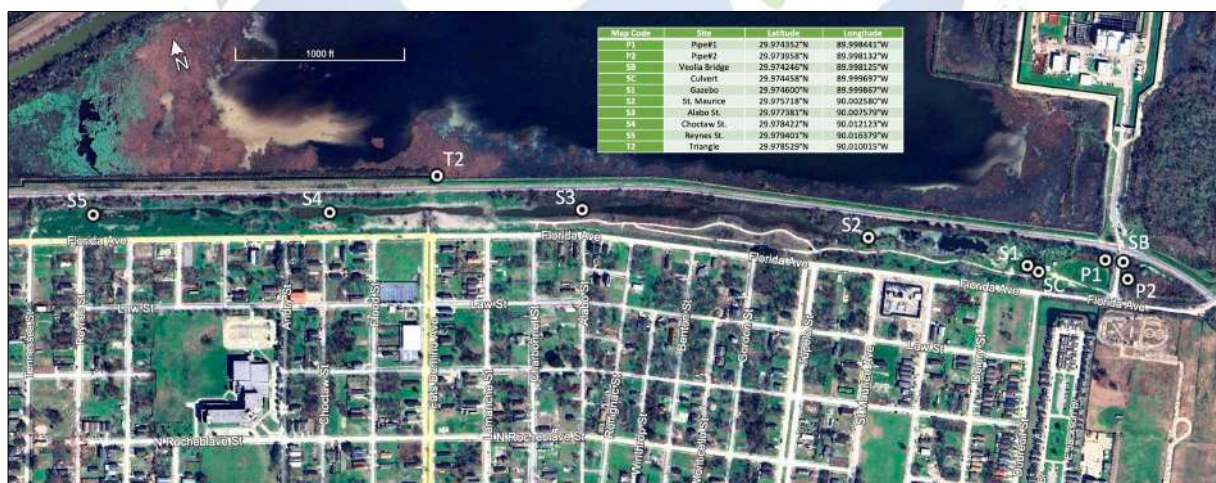
June 12, 2024: Below is a new monitoring design map that will be used for all future water quality monitoring at the wetland park until the septic issue is resolved. It includes new sites P1 at the first leaking septic pipe identified on May 7th, P2 at the second leaking septic pipe identified on May 23rd, and SC at the Sankofa Culvert.

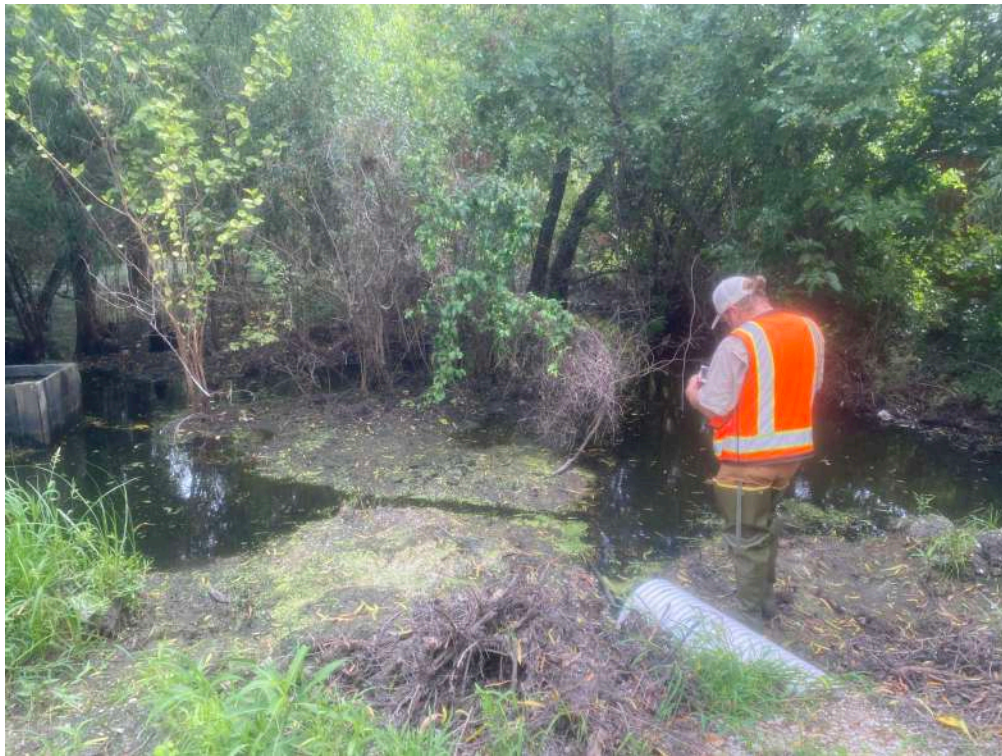
Recording water quality measurements at the Sankofa Culvert (SC) site.

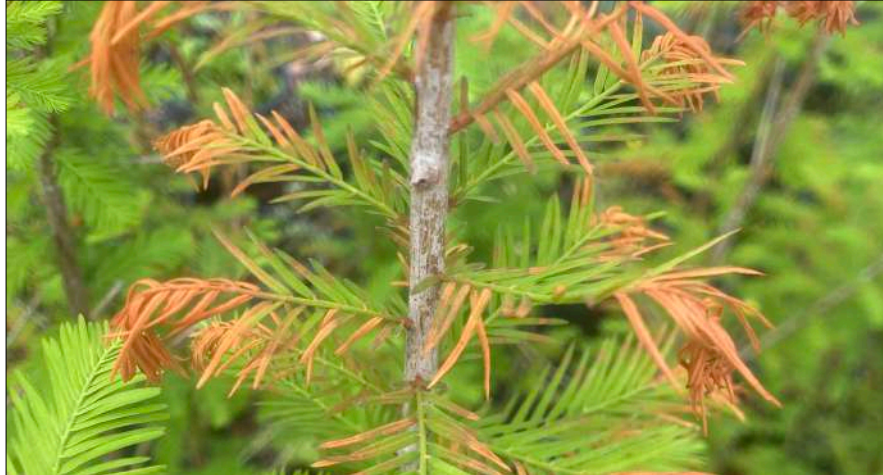
April 18, 2024: Rob Lane traveled to the park and met with Rashida and Devin. They inspected the ditch work occurring along Florida Ave., scoped out where trees are going to be planted in the park for Earth Day, and then visited the nursery. At the nursery it was discovered that many of the cypress seedling were infected with something. Further research suggests that there in a rust mite outbreak.

Potential rust mite infection of cypress seedlings.

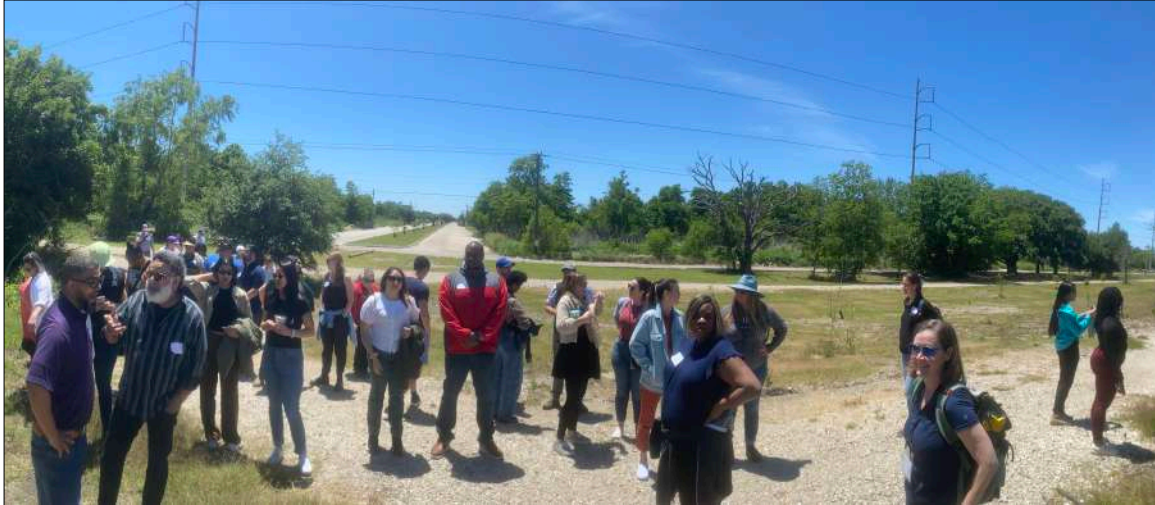
April 22, 2024: Rob Lane met with Mr. Freddie to give a tour of the park to a large group of attendees to a conference in New Orleans. Before the tour, Mr. Freddie and Dr. Lane looked around for the source of the septic water. The septic water very much seems to be localized to the area along the fence line. Beyond the fence going towards St. Bernard there is no septic smell in the channel, and it is definitely not coming in from the park.

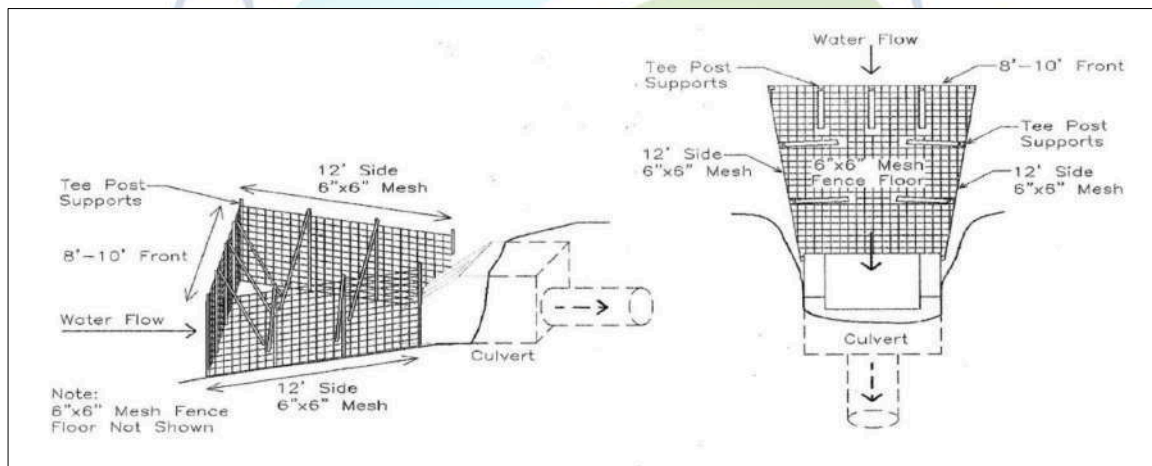
June 10, 2024: Devin Theobald contacted Comite Resources regarding a beaver dam being built near the Sankofa culvert near the fence line. Several beaver management documents were sent, both suggesting that a Keystone fence be built in front of the culvert. Below is a diagram.

A keystone fence enclosure protecting a culvert from beaver dams.

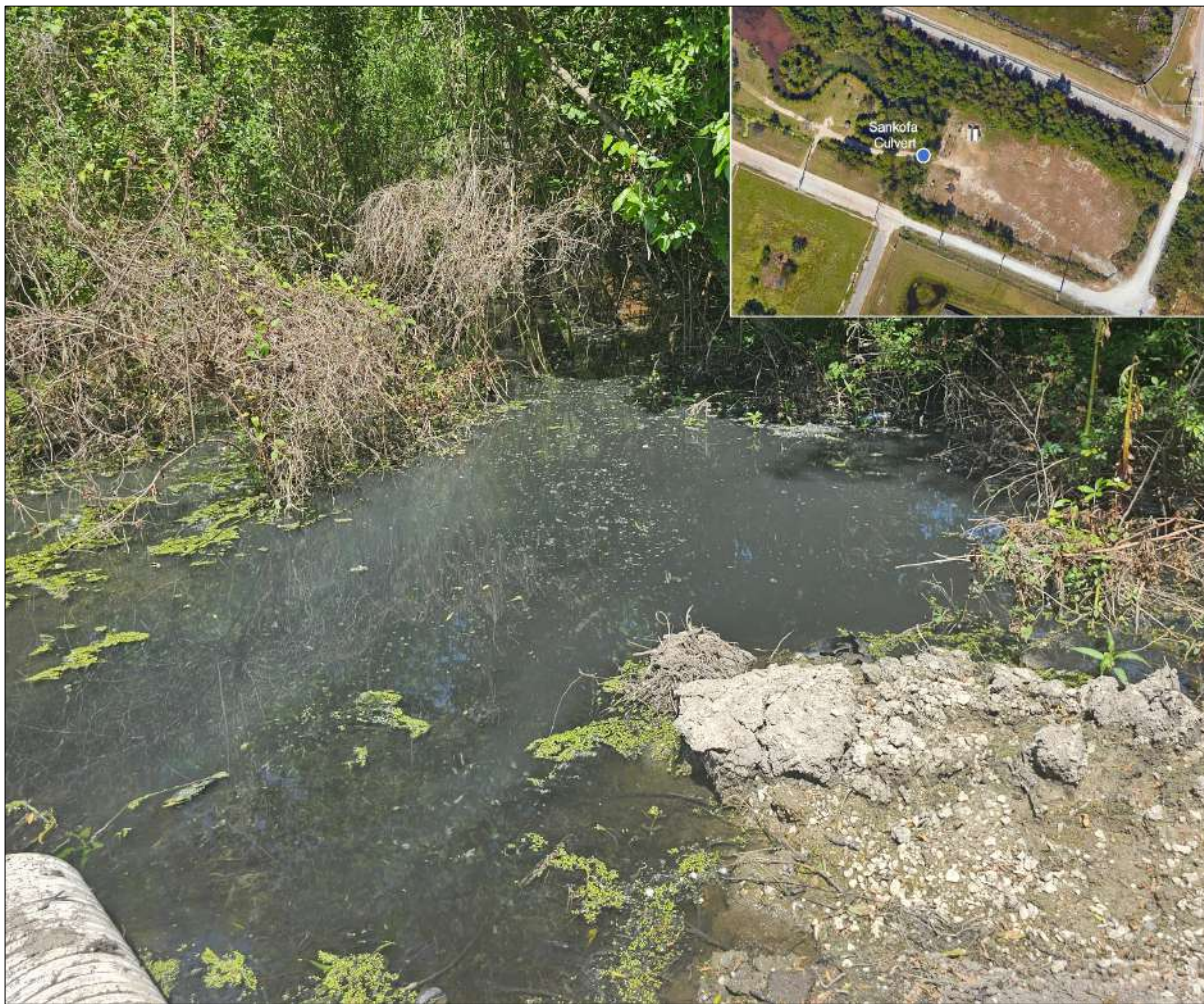
Starting in the beginning of March 2024, a distinct odor of septic water could be detected where the St. Bernard stormwater drainage canal connects with the park. In addition, the water passing through the culvert connecting the St. Bernard and L9W stormwater drainage systems was black with suspended material (Figure 1). In an effort to mitigate this, the Sewage and Water Board of New Orleans and Veolia Wastewater Treatment Plant were contacted. Despite their site visits, they were been unable to determine the cause or provide a solution.

Figure 1. Photo taken on April 4, 2024 where the St. Bernard drainage canal feeds into the wetland park and exits through a culvert. The location is indicated by the blue dot in the upper right panel.

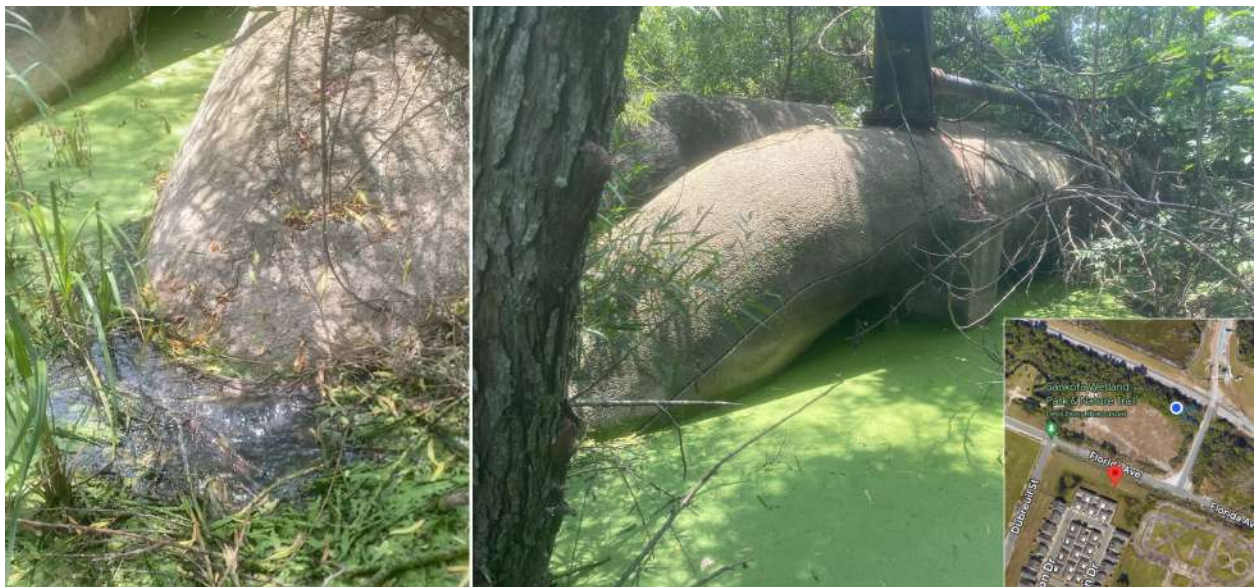
On May 7, 2024, Dr. Robert Lane of Comite Resources, an environmental advisor for Sankofa CDC, investigated the easternmost section of the St. Bernard drainage canal and identified a potential cause of concern. He discovered a large septic pipe, over 40 inches in diameter, which is part of the infrastructure leading to the Veolia Wastewater Treatment Plant, visibly leaking (Figure 2). Septic odors and effluent were emerging from the substrate around the pipe. This pipe was identified as the intake pipe transporting raw sewage to the Veolia wastewater treatment plant. However, the Sewage and Water Board of New Orleans conducted water quality tests and concluded that septic water was not leaking from the pipe, despite visible evidence of water surging from the ground at the base of the sewerage pipe.

Figure 2. Septic water leakage at the base of the forced main septic pipe leading to the Veolia WTP. The location is indicated by the blue dot in the lower right panel.

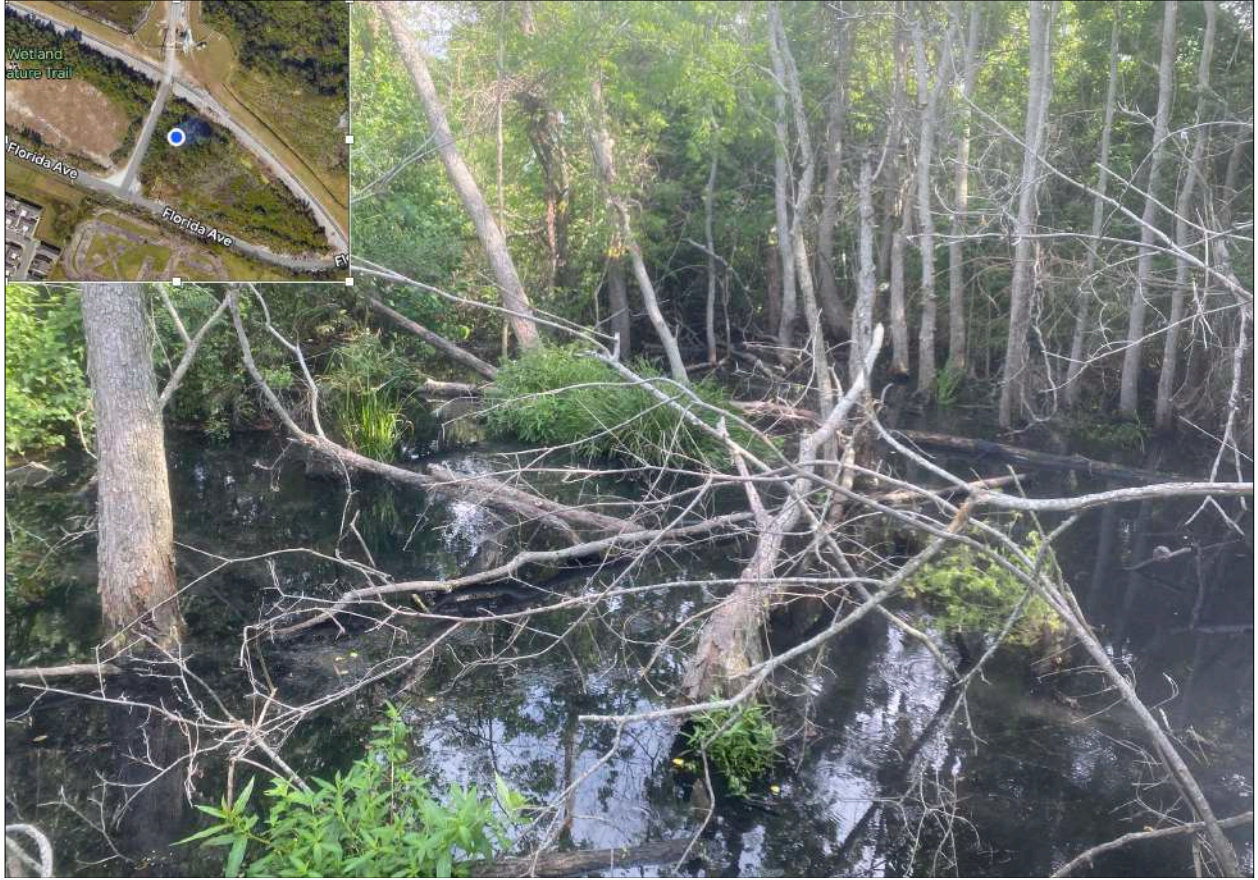
A much more substantial leak was later discovered on May 23, 2024, near a second pipe leading from the Veolia wastewater treatment plant. This area resembles a wetland but is characterized by dead trees and a flocculent mud layer (Figure 3), which was later found to contain millions of small red worms. There is a distinct septic smell and a continuous flow of water from the area directly into the St. Bernard stormwater canal. The volume of flow from the site is comparable to the flow observed through the culvert pipe at the park during dry weather conditions. This pipe was identified as carrying treated effluent from the Veolia wastewater treatment plant to be discharged into the Mississippi River. The Sewage and Water Board of New Orleans, the Veolia Wastewater Treatment Plant, and the Louisiana Department of Environmental Quality were contacted, and representatives visited the site.

Figure 3. Septic water upwelling from a buried pipe that connects to the Veolia WTP. The location is indicated by the blue dot in the upper left panel.

The causes of the two issues outlined above are very likely related. Normally, water in the St. Bernard stormwater canal flows eastward to the pumping stations located in that direction and is then discharged into the Central Wetland Unit, a vast expanse of wetlands to the north that drains into Bayou Bienvenue and then into Lake Borgne. However, a blockage in this canal in January 2024 caused water to be forced westward into the Sankofa Wetland Park. This resulted in higher water levels in the park due to a combination of septic water inflow, heavy rains, and an overly restrictive and clogged culvert connecting the St. Bernard stormwater canal to the L9W stormwater system. Consequently, the Sankofa Wetland Park has received a significant amount of septic effluent and has deteriorated significantly due to elevated nutrient levels, which have induced an overgrowth of aquatic vegetation and subsequent low dissolved oxygen concentrations. Activities and events at the park have mostly been suspended due to septic odors and negative aesthetic conditions.

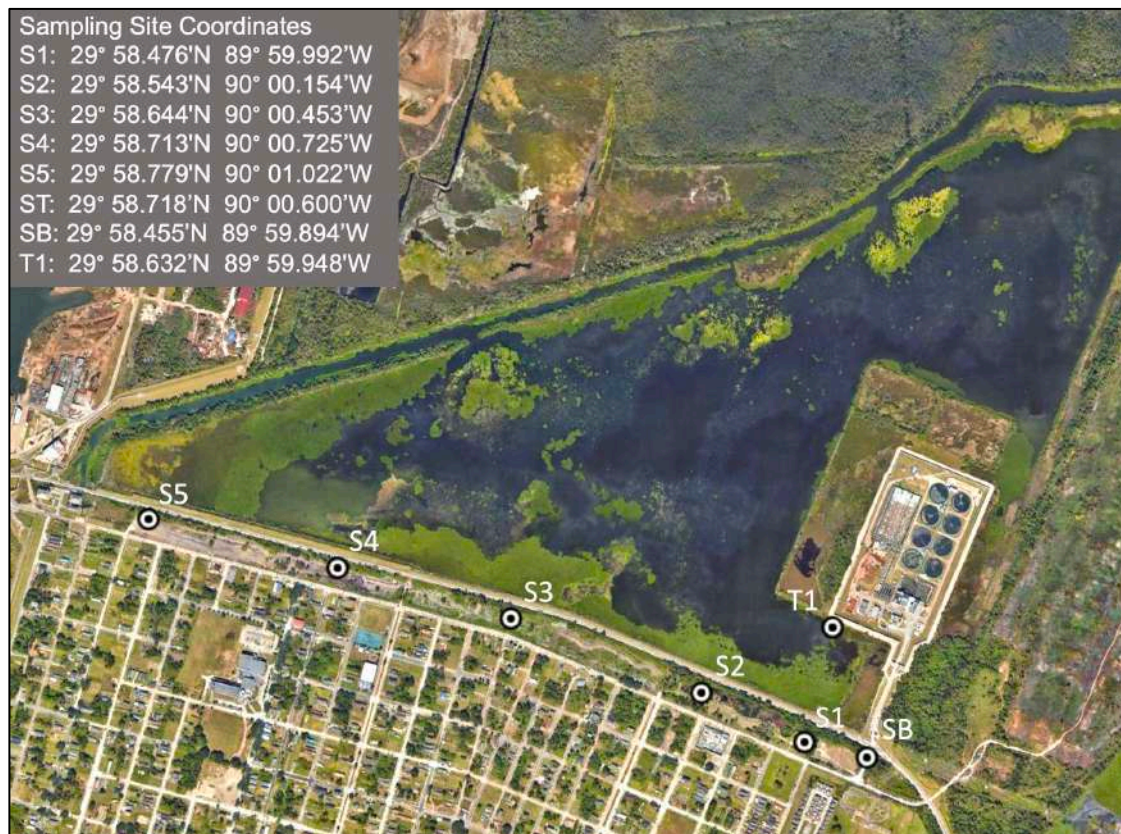
Environmental monitoring at the Sankofa Wetland Park began in January 2022. The sampling design consists of five monitoring locations (S1 through S5) set approximately equidistant along the mile long length of the linear park (Figure 4). The St. Bernard drainage ditch accessed at the bridge to the Viola Water treatment plant is also being monitored (site SB), as well as a site in the Bayou Bienvenue Wetland Triangle (site T1). In 2022, only sites S1 and S2 were monitored. Sites S3-S5, as well as SB and T1 were added as the wetland park was expanded in 2023.

Figure 4. Location of sampling sites at the Sankofa Wetland Park (S1-S5), the St. Bernard drainage ditch (SB), and the Bayou Bienvenue Wetland Triangle (site T1).

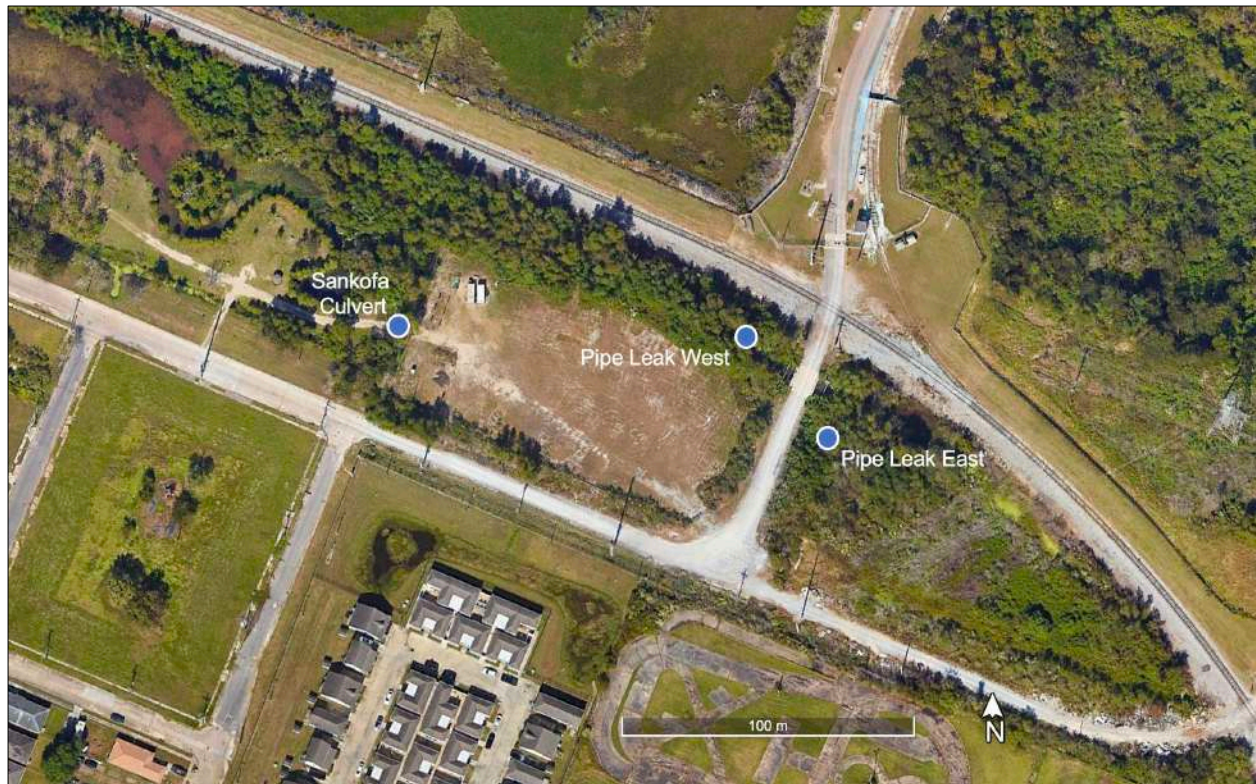
Additional samples were collected on May 23, 2024 for Fecal Coliform, E. Coli and Enterococcus bacteria analysis, as recommended by Kristi Trail of the Pontchartrain Conservancy. The samples were collected at the two leaking pipes described above located east and west of the road to the Veolia wastewater treatment plant, as well as at the Sankofa Wetland Park culvert (Figure 5).

Figure 5. Locations where samples were taken on May 23, 2024.

The additional samples collected on May 23, 2024, for Fecal Coliform, E. Coli, and Enterococcus bacteria analysis provide critical insights into the microbial contamination in the vicinity of the Veolia wastewater treatment plant and Sankofa Wetland Park with significant variations in bacterial concentrations across the three sampling locations. Fecal coliform bacteria were found to be 265 CFU/100 mL at the eastern pipe leak, 110 CFU/100 mL at the western pipe leak, and a notably high 480 CFU/100 mL at the Sankofa culvert (Table 3). Similarly, E. coli concentrations were 435.2 MPN/100 mL at the eastern pipe leak, 313.0 MPN/100 mL at the western pipe leak, and 694.7 MPN/100 mL at the Sankofa culvert. Enterococcus bacteria levels were 307.6 MPN/100 mL, 64.2 MPN/100 mL, and 119.1 MPN/100 mL at the eastern pipe leak, western pipe leak, and Sankofa culvert, respectively (Table 3).

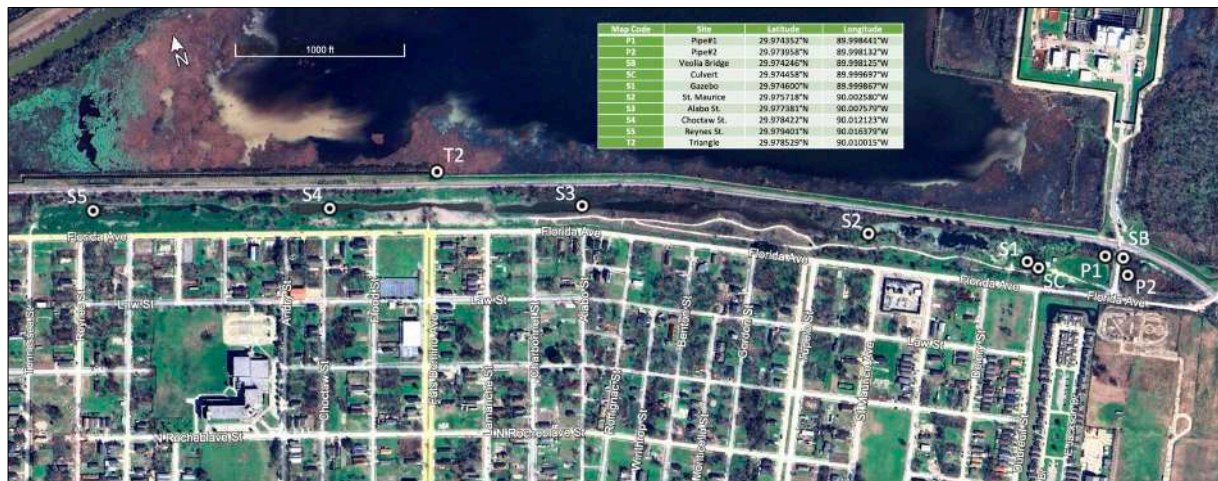
June 17, 2024: Monthly monitoring was carried out that included new sites P1 at the first leaking septic pipe identified on May 7th, P2 at the second leaking septic pipe identified on May 23rd, and SC at the Sankofa culvert (Figure 6). Dissolved oxygen, conductivity, temperature, salinity and pH were measured at all of the new and old monitoring sites using a handheld probe. There was no flow from either of the leaking pipes. Site P2 had little to no standing water, except the hole where water was observed welling up from the pipe on May 23.

Figure 6. Map of revised monitoring design.

Dissolved oxygen was 1.0 mg/L at the bridge (SB), 0.6 mg/L at the first leaking septic pipe (P1, formally SP), 0.9 mg/L at the second leaking pipe (P2), and 1.5 mg/L at the Sankofa culvert (SC; Table 4; Figure 6). Dissolved oxygen ranged from 0.6 to 3.5 mg/L at the wetland park sites (S1-S5), and was 1.1 mg/L at the wetland triangle (T2). Conductivity was ~1400 mS at SB, ~1800

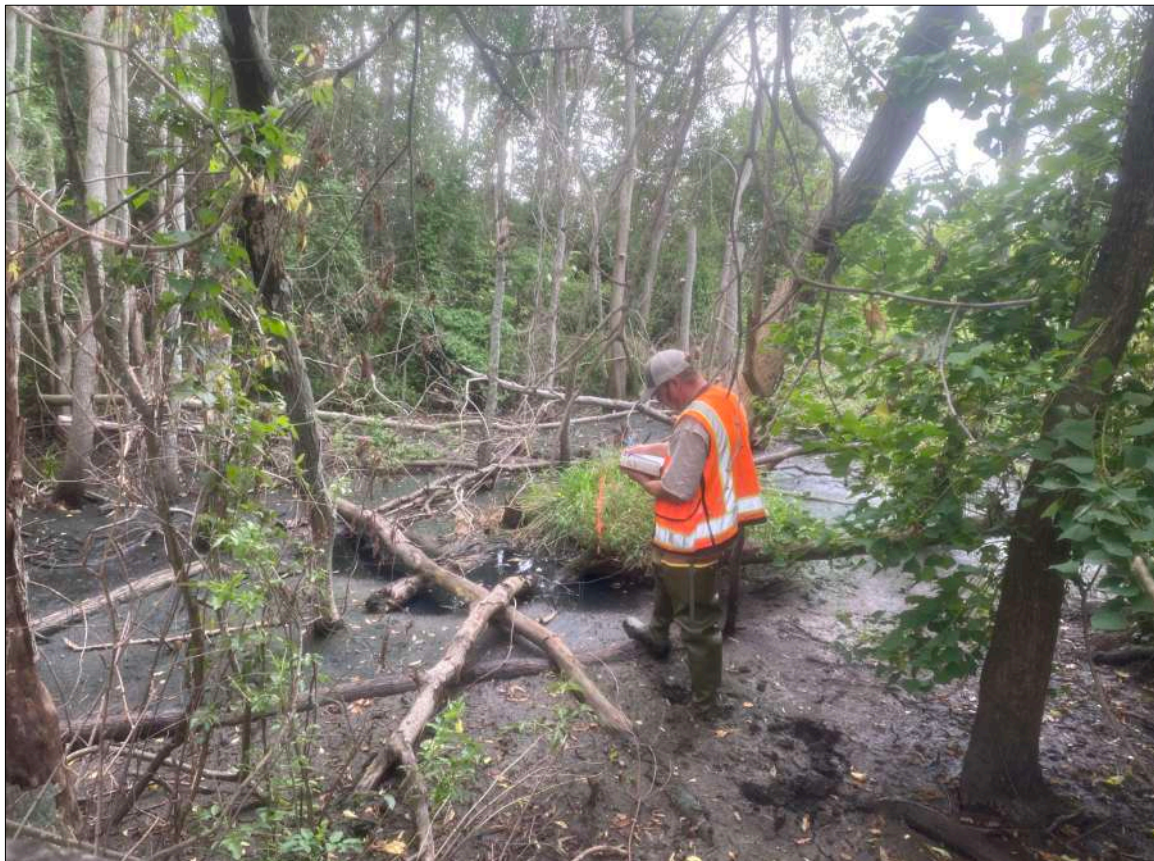
Figure 7. Site P2 on June 17th, 2024.

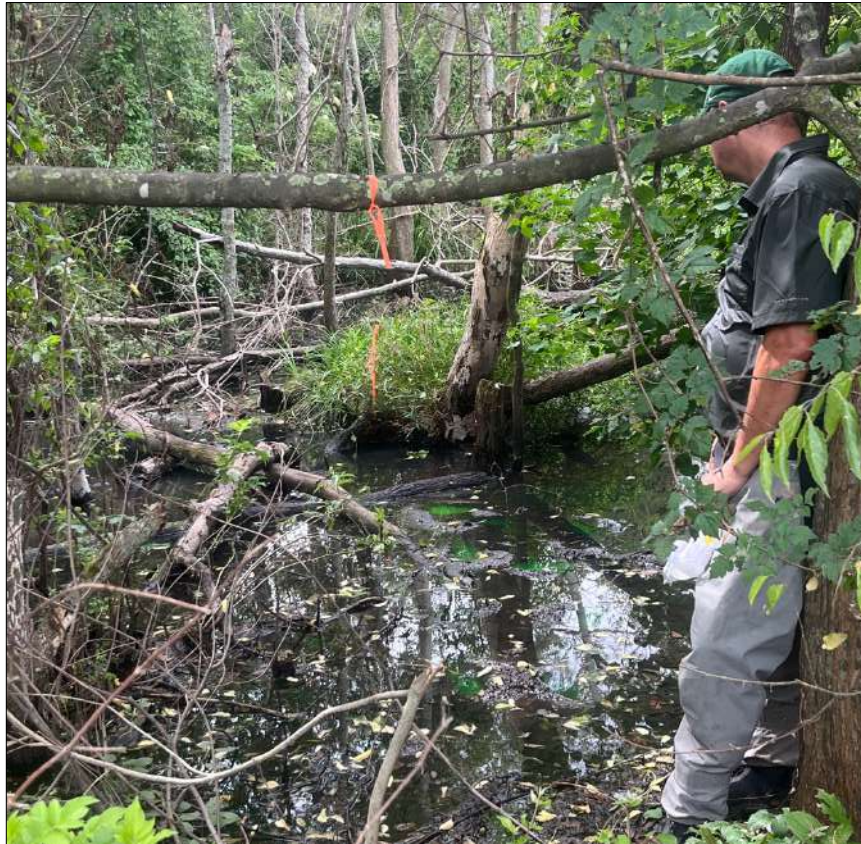
June 17, 2024: Dr. Rob Lane returned to the Sankofa Wetland Park for a meeting with CPRA. He was surprised to find water welling up from the pipe at P1, which CPRA representatives Brandon Champagne and Skylar Liner also observed. There was significant standing water at site P2, however, there was no movement, but there was fluorescent green dye present in the water that had collected in footprints left from earlier visits (Figure 8). Water samples were collected from all sites for fecal coliform, ammonia and total nitrogen analysis.

Figure 8. Site P2 on June 20th, 2024. Notice standing water and green dye.
